Integrated Transport Feasibility Study

ICTP-2017-12 A606 Langham

Introduction

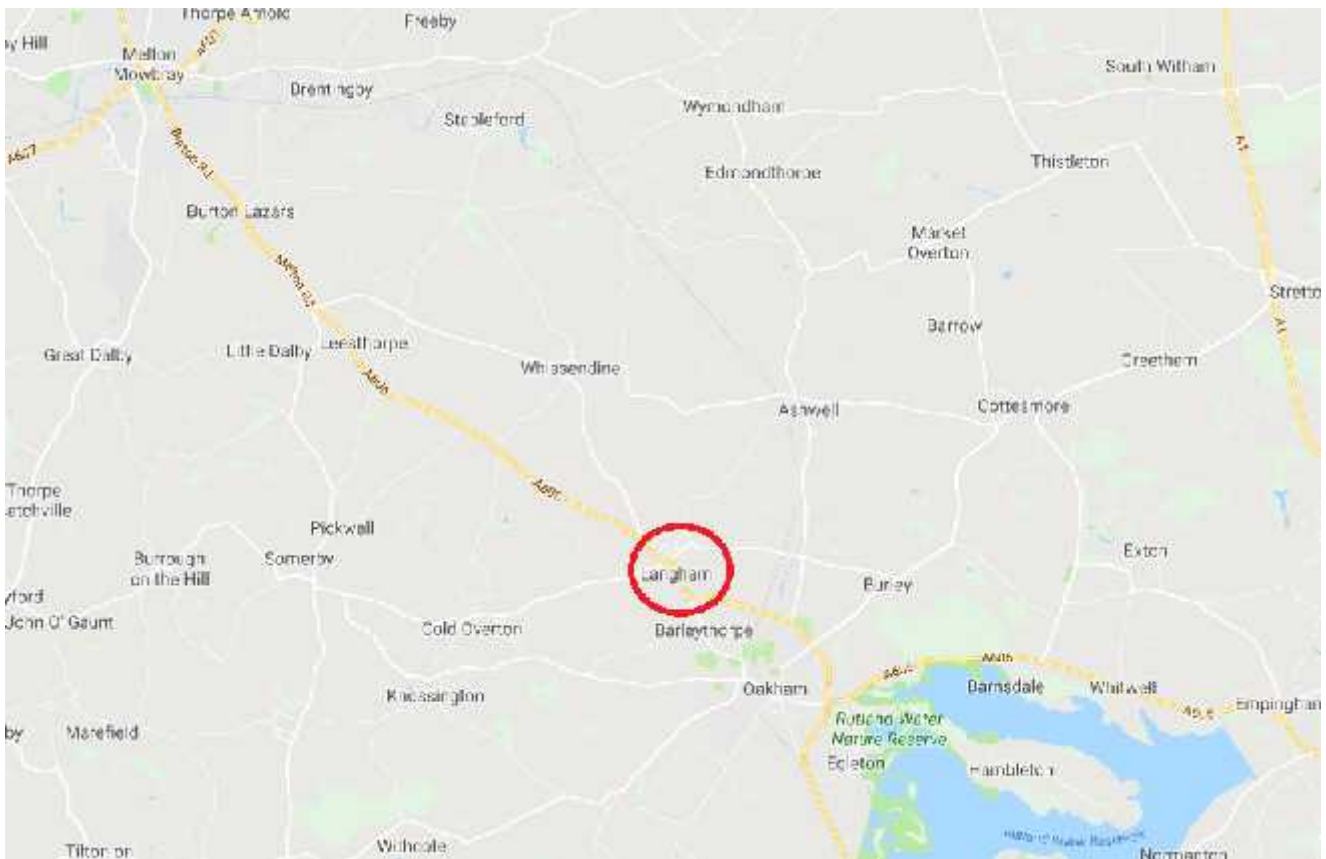
The speed limit on the north-bound approach to Langham is 40mph, this reduces to 30mph, 230m south of the junction with Burley Road.

The speed limit throughout the village is 30mph and this increases to national speed limit (60mph) west of the junction of Whissendine Road.

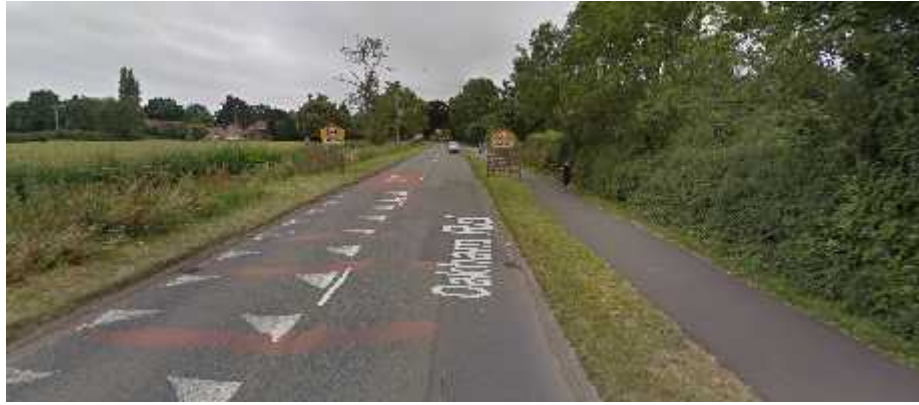
The approach to Langham along the A606 from Oakham is a long straight road. This section of road already benefits from some gateway features, such as large village name plate on yellow backing, wooden gateways, dragon teeth markings and red high friction surfacing. The white lines and high friction surfacing at this location have faded over time but are still visible.

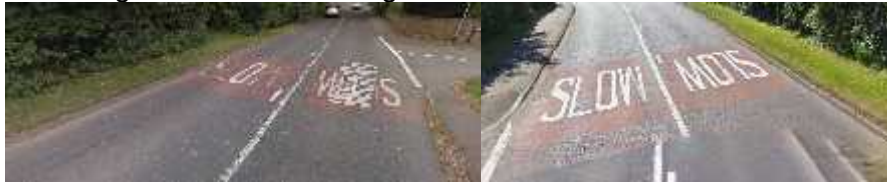
Red high friction surfacing with SLOW markings – this has been faded over time but is still visible.

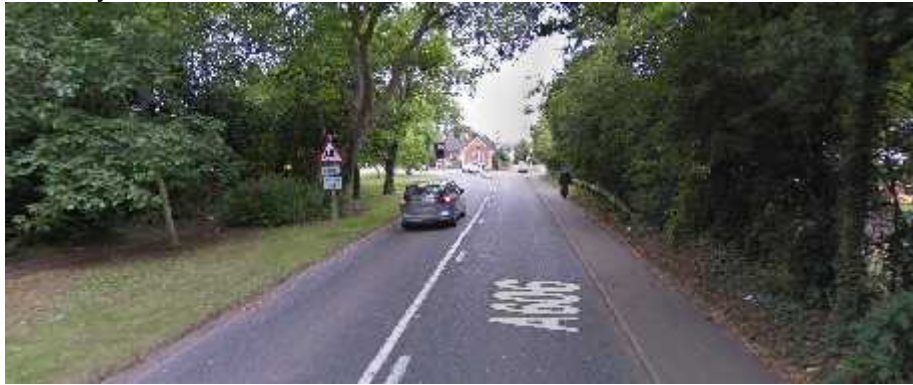
SID just south of Burley Road for north bound traffic

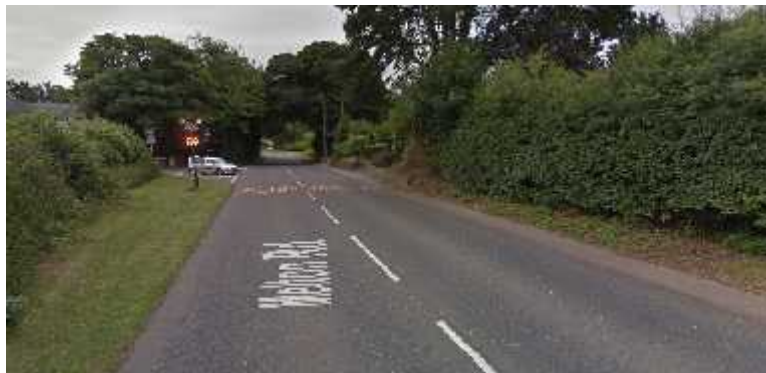
SID just north of Manor Lane for south bound traffic

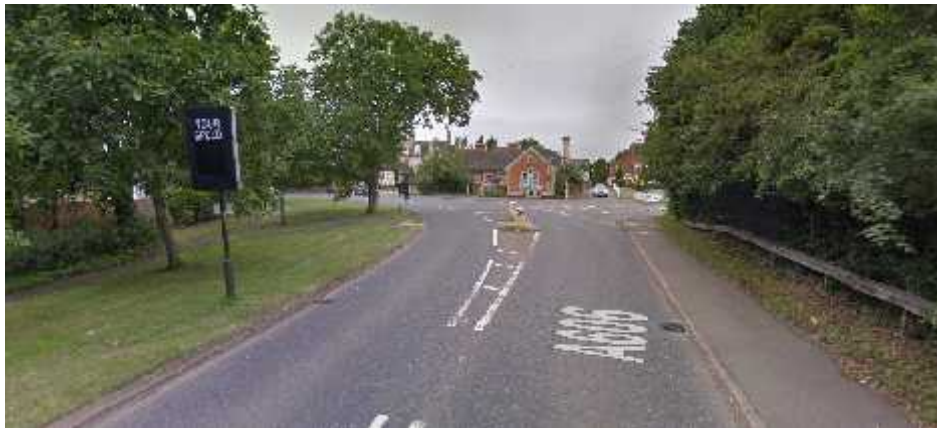
South of the junction of Burley Road and the A606, there is an uncontrolled pedestrian crossing comprising of a pedestrian refuge island. This crossing is used by parents and children to access the primary school adjacent to the A606 and residents walking towards Oakham.

This is the only formal crossing point throughout Langham.

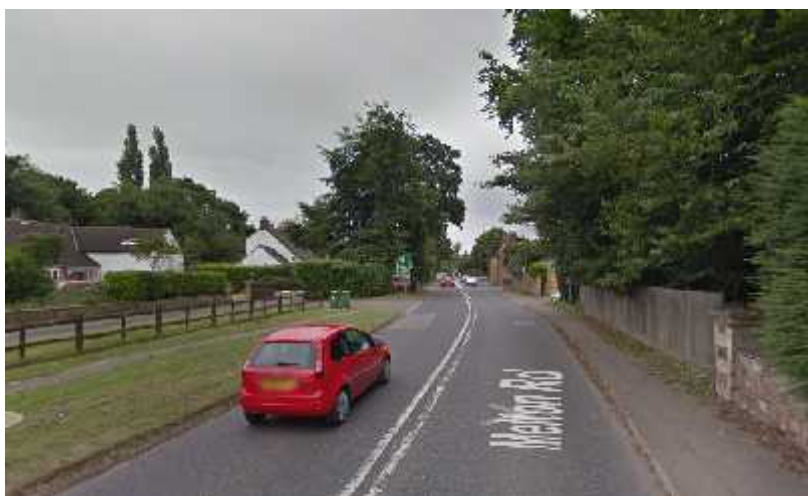
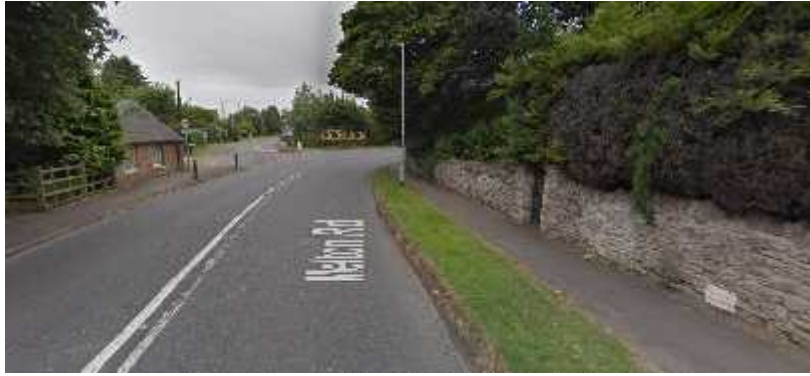
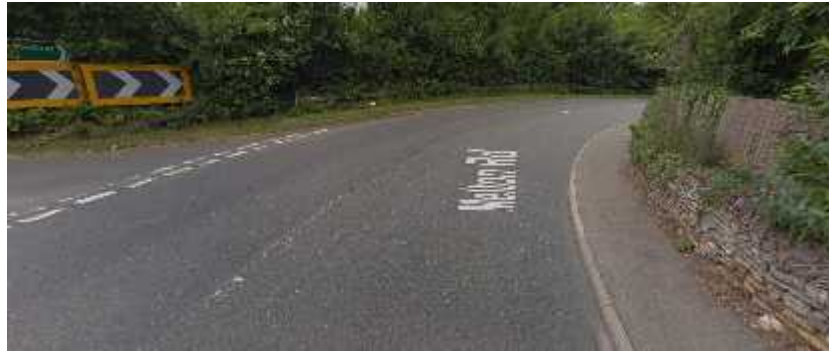
West of Burley Road junction, there is a solid white lines system, until just north of Cold Overton Road. There are no pedestrian crossing points along this section of road. There is a footpath on both the north and south side of the carriageway. The footpath on the south is 1.2m wide and the footpath on the north side is 1.8m wide, however is reduced at some locations due to overgrown vegetation.

There is a sharp right hand bend at the Cold Overton Road junction, this helps with traffic calming as vehicles are forced to slow down. The footpath along this section of road is reduced down to 1m. Due to the road layout and highway boundary, there is no scope to widen the footpath at this location.

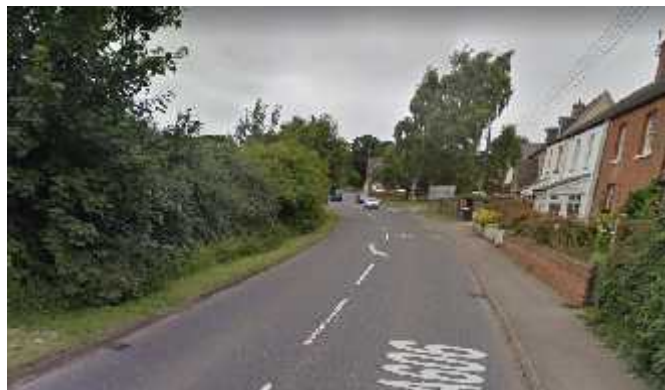
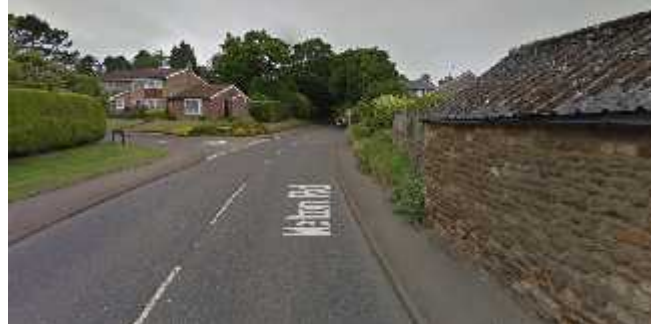
Between Cold Overton Road junction and Whissendine Road, the road is relatively straight, with two gentle sweeping bends. The road benefits from a footpath to the eastern side of the road, measuring 1.3m wide, from Burley Road up to the junction with Cold Overton Road, continuing to Manor Lane.

There is footpath on the western side of the road from opposite Well Street to Ranksborough Drive. The footpath has reduced in size due to overgrown vegetation encroaching onto the footpath. This has caused the footpath to be narrowed to 1.2m adjacent to the entrance to Ranksborough Drive.

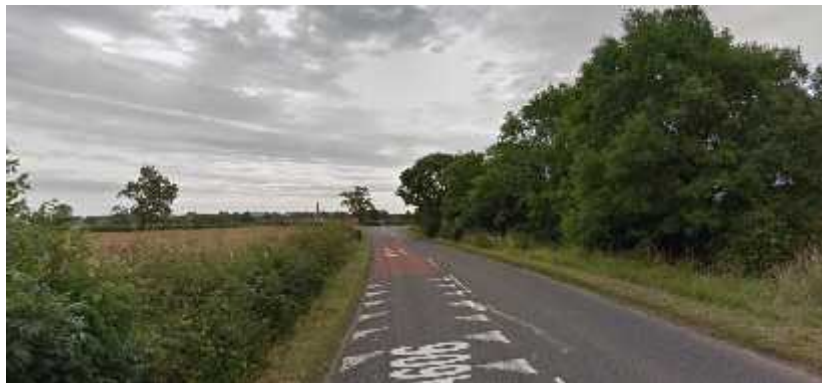
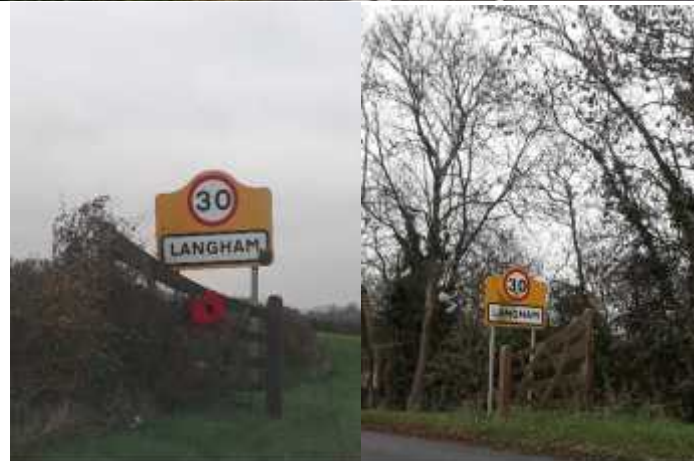
The northern end of Langham benefits from a similar gateway to the southern end; a large village name plate on yellow backing, wooden gateways, dragon's teeth markings and red high friction surfacing.

The 30mph limit is just outside of the village limits and could be seen as open country side by drivers as there is no discernible change in the surrounding landscape.

The existing 30mph limit along the A606 for Langham on the approach from Melton has been positioned in a suitable location. It is set 100m from the first property in Langham, 250m away from the main built up area and just west of the junction with Whissendine Road. It would not be appropriate to position the 30mph limit further out of the village, as there is no change in landscaping and in open countryside.

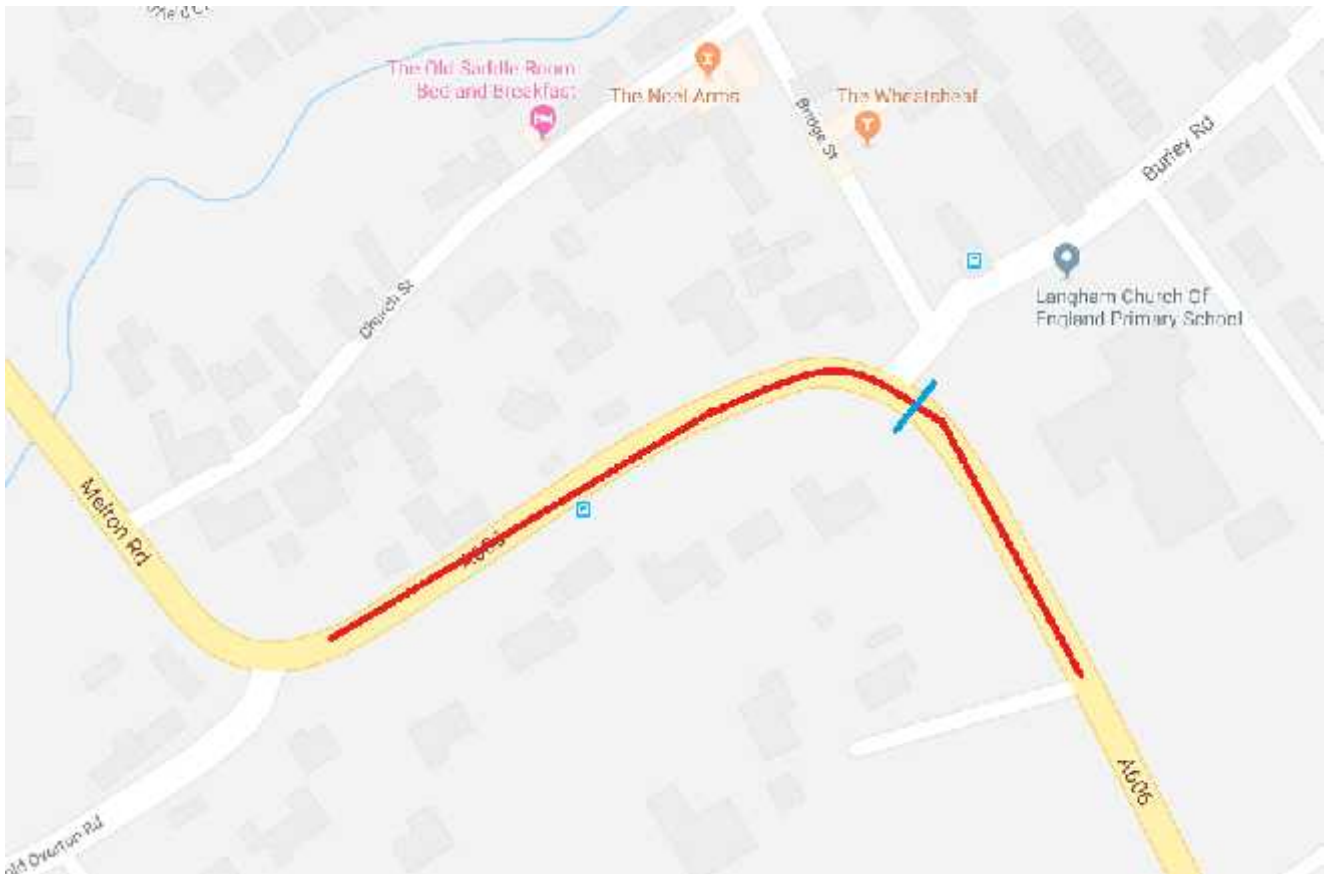
The survey looked at the area highlighted in red on the plan below; but specifically looked at the refuge island crossing, highlighted in blue.

The refuge island is used by the majority of pedestrians travelling west to east to cross the A606. The refuge island is 2.5m wide; this is above the requirement minimum specified in the LTN 2/95. The pedestrians observed would cross half of the road and then wait on the pedestrian refuge until they can cross the next second half of the road.

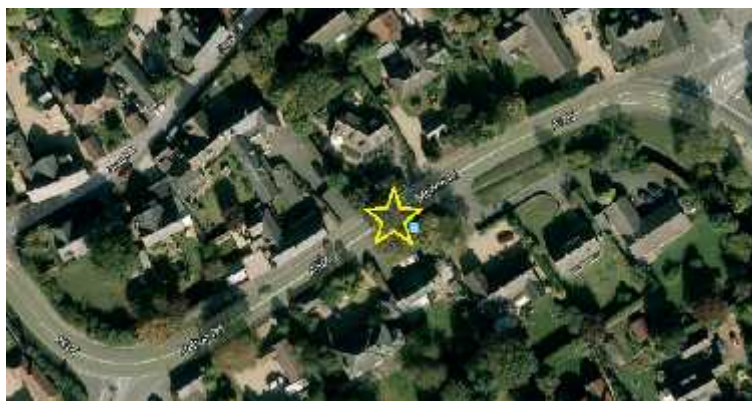
The only suitable location along this section of road for a crossing is outside the bus stops on Melton Road, as highlighted below. This location has wide footpaths on either side of the road, and scope within the adopted highway to install the required street furniture. There is adequate forward visibility for vehicles to see the approaching crossing point.

If a crossing is installed at this location, users will be required to cross the road 3 times rather than once. They will need to cross Melton Road A606 at the new controlled crossing, then Church Street and then Burley Road; rather than just the A606 at the pedestrian refuge.

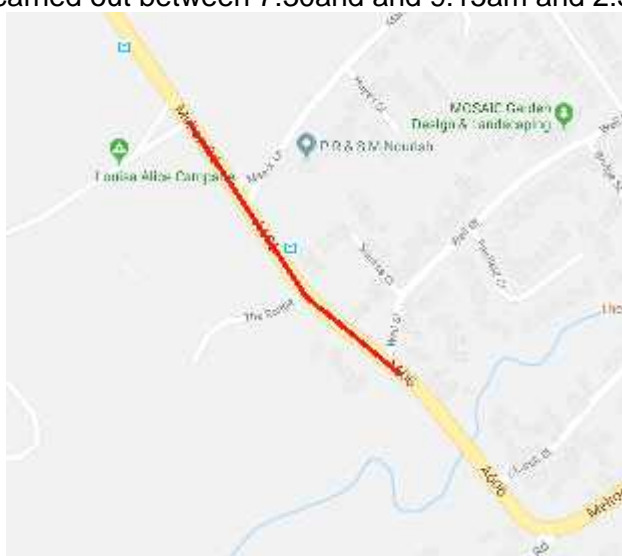
Survey 2 was carried out on the corner of Melton Road A606, between The Range and Well Street, between 12/11/2018 and 16/11/2018. The survey looked at the area highlighted in red on the plan below. The surveys were carried out between 7:30am and 9:15am and 2:30am and 4pm.

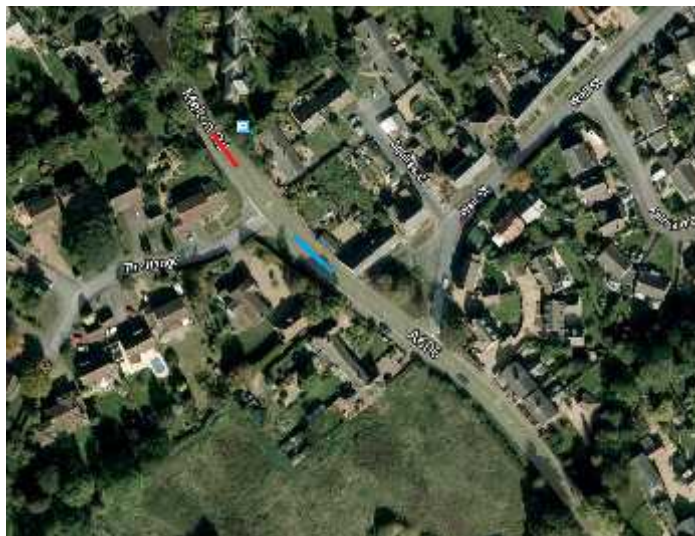
On Melton Road near The Range and Well Street, there are 2 main areas that residents use to cross the road. These locations offer the best visibility splays in both directions. The area shown in red on

the plan below was only used by a handful of pedestrians crossing the road. These were predominantly dog walkers who saw a gap in the traffic so decided to cross. The area shown in blue on the plan below is where the majority of pedestrians crossed the road. This included primary school children with parents, dog walkers and Catmose Students. This location is on the pedestrian desire line for those coming from The Range accessing the primary/secondary school, and those walking into the village/Oakham.

The area shown in red on the plan above is not on the desire line for the majority of pedestrians crossing the road. The Local Transport Note 2/95 also requires a road to be a minimum of 8.2m wide to accommodate a refuge island. However the road width at this location is approximately 6.4m wide. Therefore this is not a suitable location for a pedestrian refuge island.

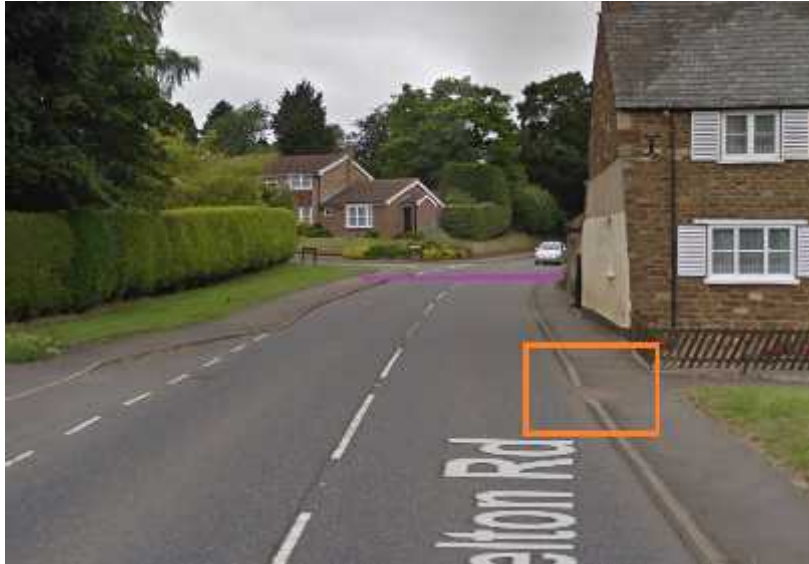
Along the east side of Melton Road there are only 2 dropped crossing, however on the west side there is only 1. The dropped crossing on both sides of the road is not at the ideal location for pedestrians to cross (shown in orange on the image below). For pedestrians walking east to west the visibility splay is blocked north by a building. Therefore pedestrians walk north of the existing dropped crossing in order to cross the road – this is shown in purple on the plan below. This location has good visibility in both directions but does not benefit from a dropped crossing.

This section of carriageway is 6.6m in width and therefore is below the required width to install a pedestrian refuge island; therefore it is not a suitable location for a pedestrian refuge island.

The most suitable location for a pelican crossing along this section of the A606 in terms of observed pedestrian movements and desire lines, would be at the existing dropped crossing on Melton Road, shown in orange on the plan above. However this is not an ideal location as the visibility splay is limited to the north. To make this location suitable a large proportion of the layby, south of The Range, would have to be removed to accommodate the pedestrian crossing footpath requirements and visibility splays. This would reduce the parking for the properties adjacent to the layby.

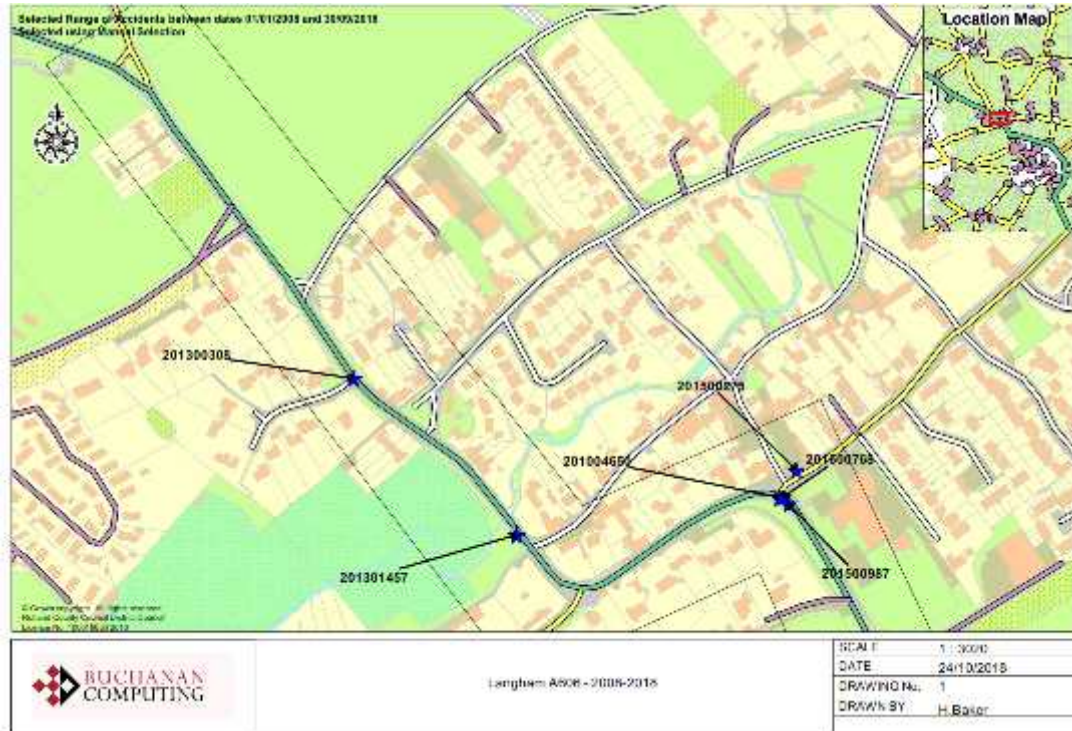
There have been 6 recorded accidents between 1/1/2008 and 30/9/2018:

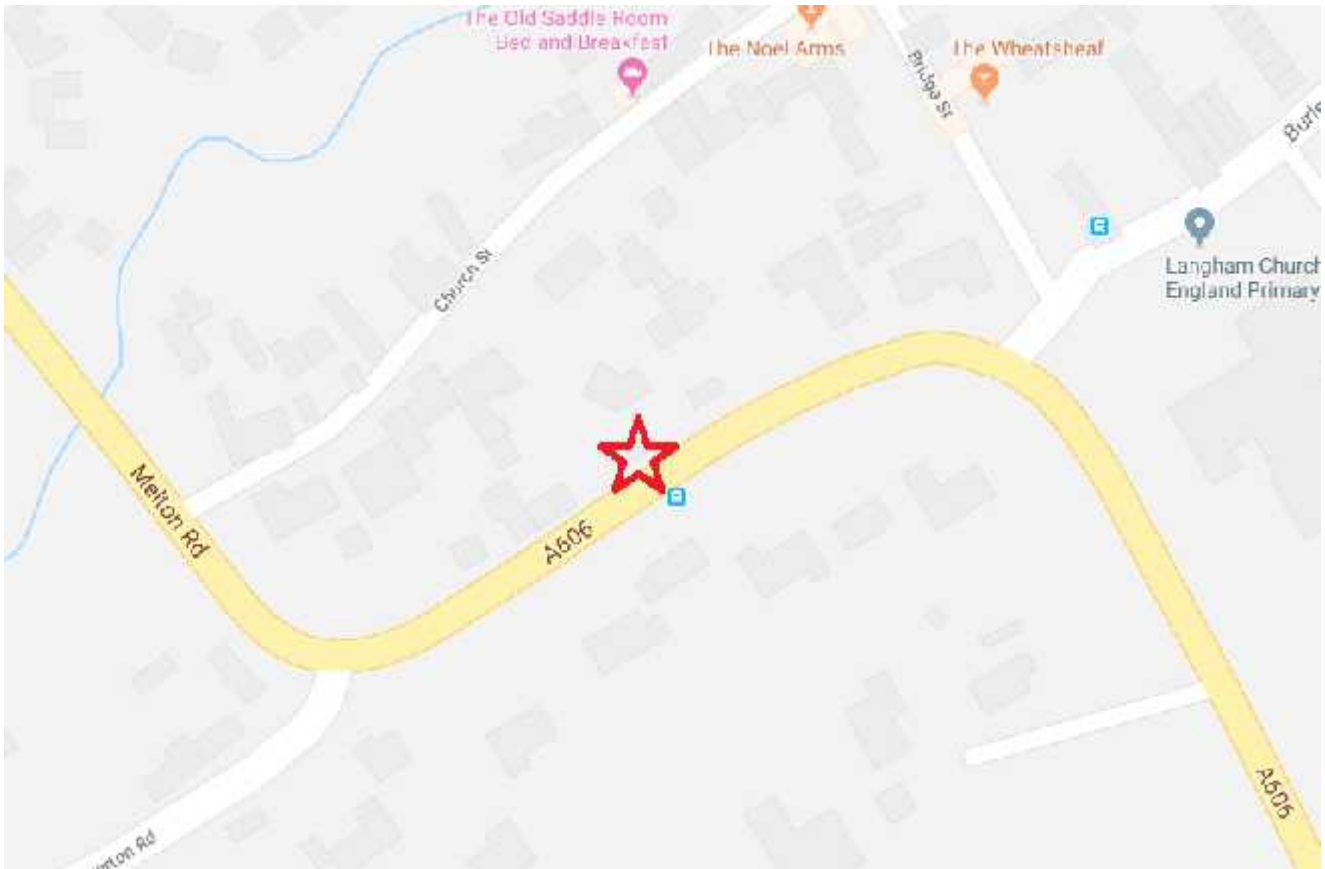
The approaching data is vehicles travelling north towards Melton.
The overall average speed was 26mph and the overall average 85th percentile was 29mph.

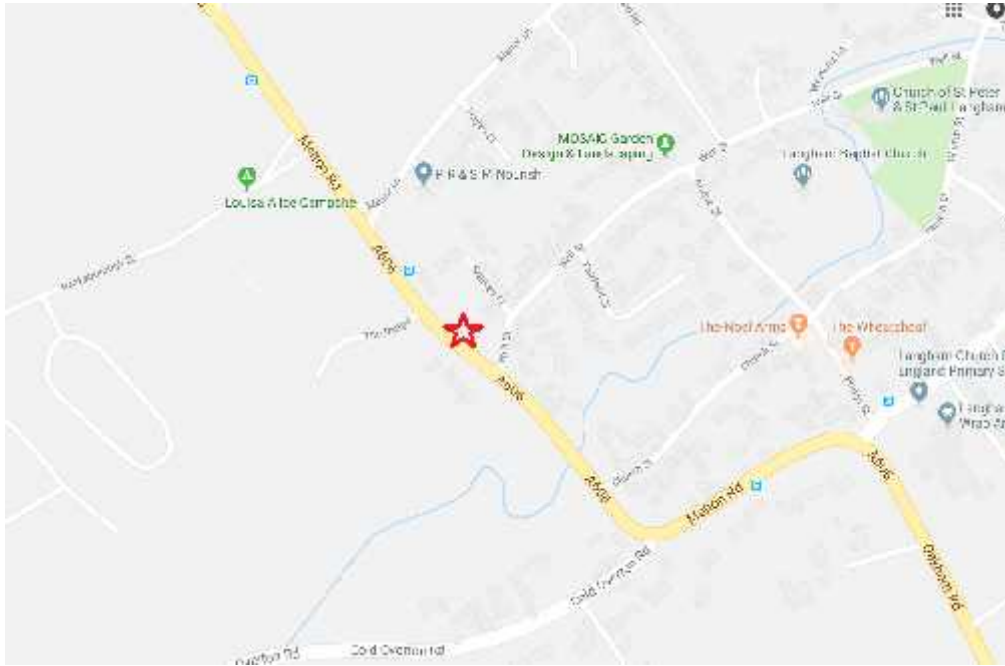
The overall average speed was 27mph and the 85th Percentile was 31mph.

The recorded average speeds are all below 30mph.

The 85th percentile vehicle speeds heading into the village (receding data) are below 30mph, however the speeds of vehicles existing the village are just above 30mph.

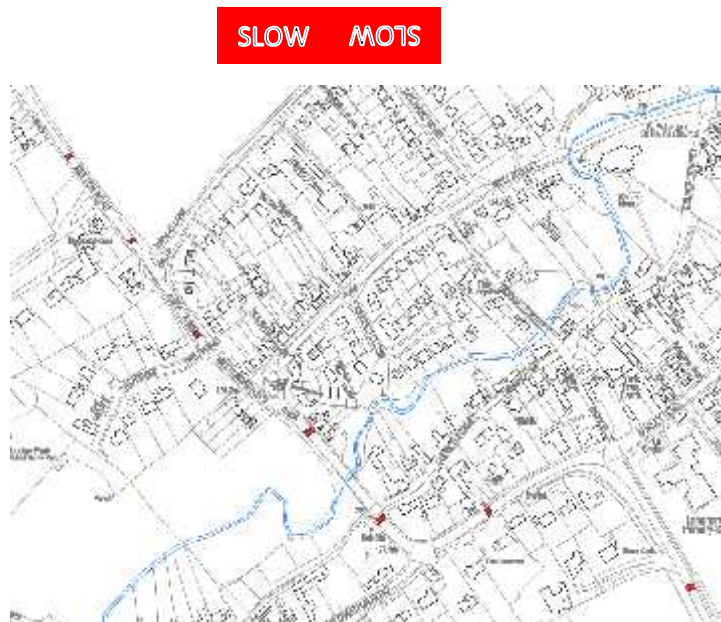
Improve the existing white lining and red high friction surfacing along the A606, including high friction surfacing with SLOW marking. As illustrated below:

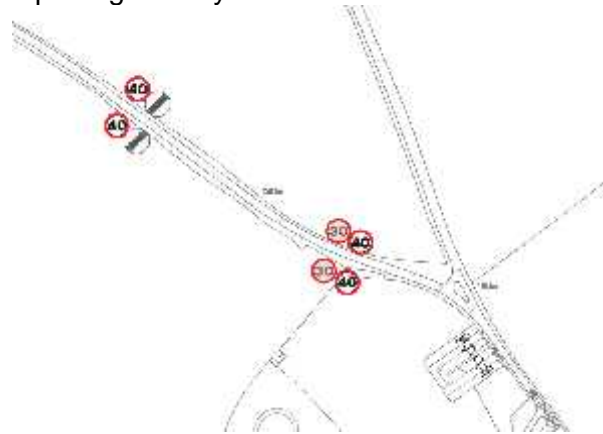
Relocate the 30mph just before the first dwelling on the A606 and create a 40mph buffer zone from the existing 30mph, including Whissendine Road. This speed limit will be more self-enforcing and allows vehicles to alter their speed gradually.

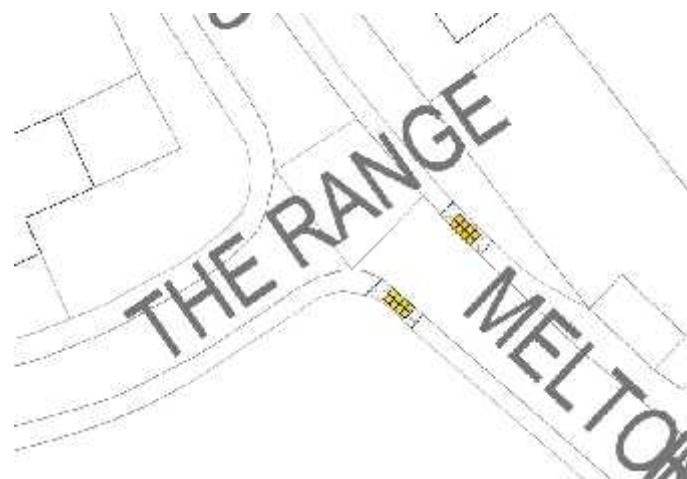
Installation of a dropped crossing including tactile paving, south of The Range junction with Melton Road. There is currently no formal pedestrian dropped crossings along this section.

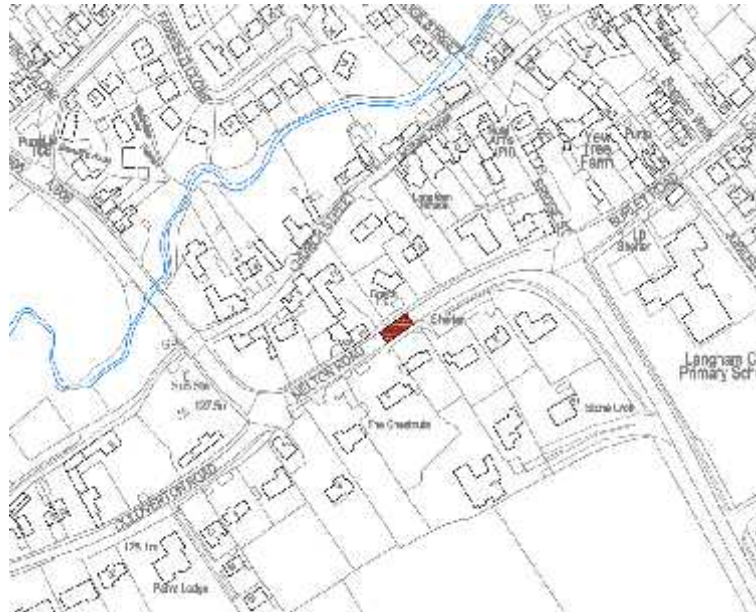
There is only 1 suitable location for a controlled crossing on the A606. This has been illustrated below.

If this is to be implemented for residents accessing the primary school or walking towards Oakham, the residents will have to cross at the pelican crossing, then cross Bridge Street and then Burley Road. This is not on the desire line for the majority of residents.
